CellComSL Series Alarm Communicators January 2016

Hardware Update

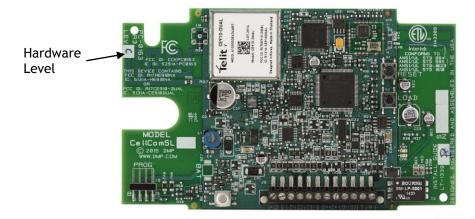
The following issue only occurred with CellComSLC Series Communicators manufactured with PC-0163 Level B hardware. This issue does not occur on the previous CellcomSLC Series manufactured on PC-0159. See Technical Update TU-0829 released December 21, 2015.

When using Zone 3 as a zone input connection, the CellComSL with Level B hardware would always report the zone as open. This would occur even though the end of line resistor was in a normal condition.

To update a Level B CellComSLC to Level C hardware, return the CellComSLC to DMP and simply indicate "Update to Latest Revision" on the RMA tag. This update will be provided at no charge. If you need RMA tags, contact DMP Customer Service at 1-800-641-4282.
