## 1139 Hardware Update

February 2008

Effective February 2008, all 1139 Wireless Bill Traps are now manufactured with updated Level B hardware.

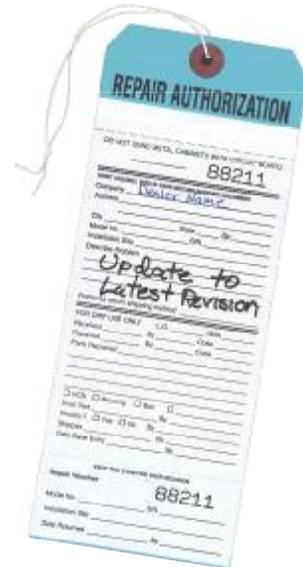
Level Indicator

New Level B hardware for the 1139 Wireless Bill Trap corrects an issue where a low battery condition occurred after 4 – 6 months of normal operation. The Level B hardware provides the expected 1 year of battery life for the 1139.

To update, return any older Level A 1139 Bill Traps to DMP and simply indicate "Update to Latest Hardware Level B" on the RMA tag. The update will be done as a Warranty Repair at no charge, regardless of when the 1139 was purchased. If you need RMA tags, contact DMP Customer Service at 1-800-641-4282.
