## XT30/XT50/XTL Series Panels

March 2015

### Version 121 Firmware Update

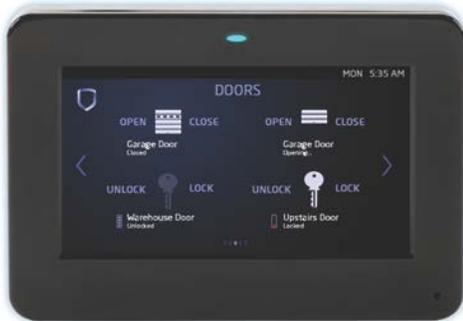
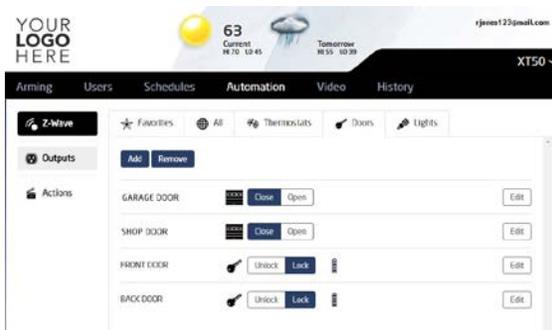
#### Z-Wave Garage Doors

The XT30/XT50 and XTL Series Control Panels now support Z-Wave Garage Doors, such as the model Z-GD00Z-4. The Locks Screens of the 7800 Series Graphic Touchscreen Keypad, MyVirtualKeypad.com Browser and the Virtual keypad App have been renamed Doors and now display Z-Wave Garage Doors, Z-Wave Locks, and Door Devices.
