Model 7872 Graphic Keypads

March 2013

Hardware Update

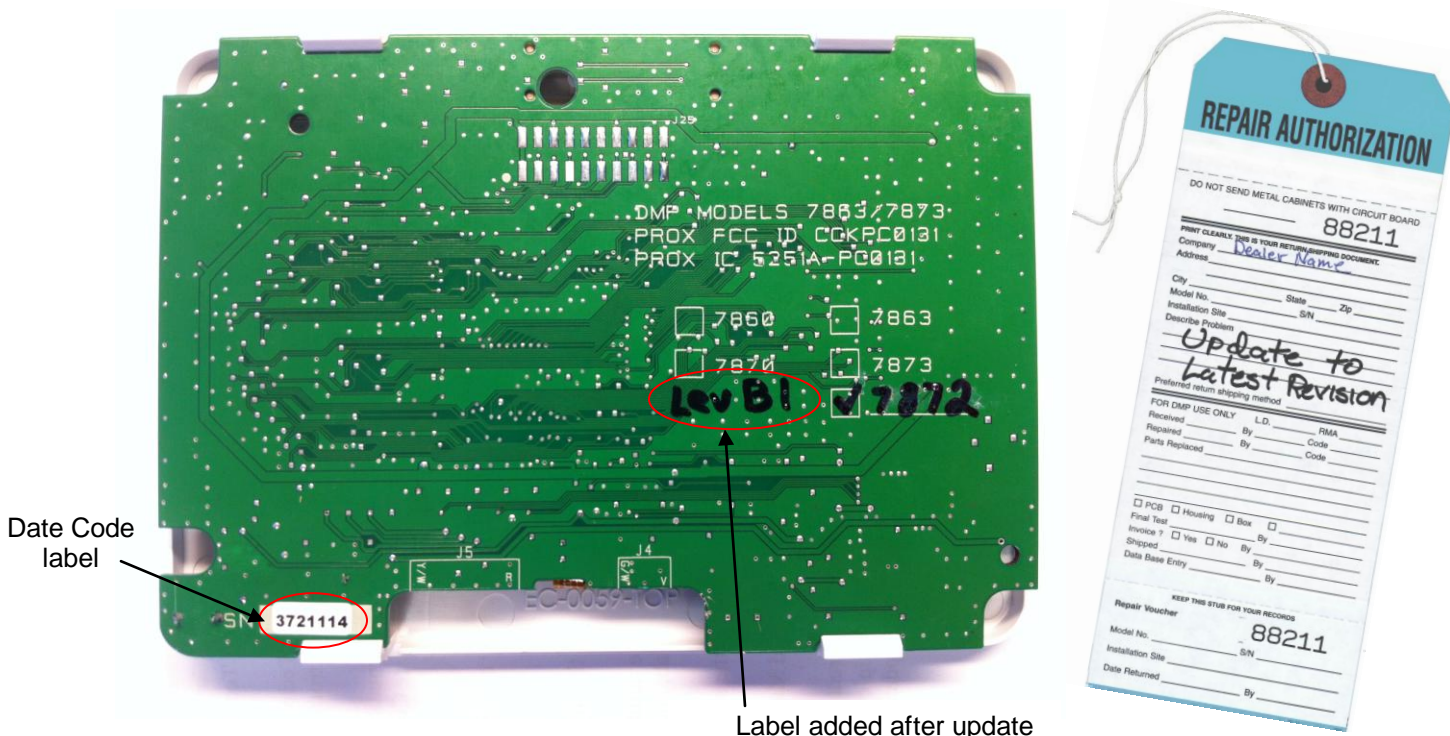
To determine if a keypad should be updated, refer to the Date Code label on the back of the PCB. If the number is less than 3741156 the keypad has not received the updated hardware. Return the 7872 Graphic Keypad to DMP and simply indicate "Update to Latest Hardware Level" on the 5-digit RMA tag. The update will be done as a Warranty Repair at no charge, regardless of when the keypad was purchased. If a 7800 Series Graphic Keypad is returned for other repair needs, this update will be automatically performed as standard repair procedure. After the keypad has been updated an indication will be added to the back of the PCB. If you need RMA tags, contact DMP Customer Service at 1-800-641-4282.
